Cultural Heritage Report: Existing Conditions and Preliminary Impact Assessment

New Pelham Elevated Tank Municipal Class Environmental Assessment

Town of Pelham Regional Municipality of Niagara, Ontario

Final Report

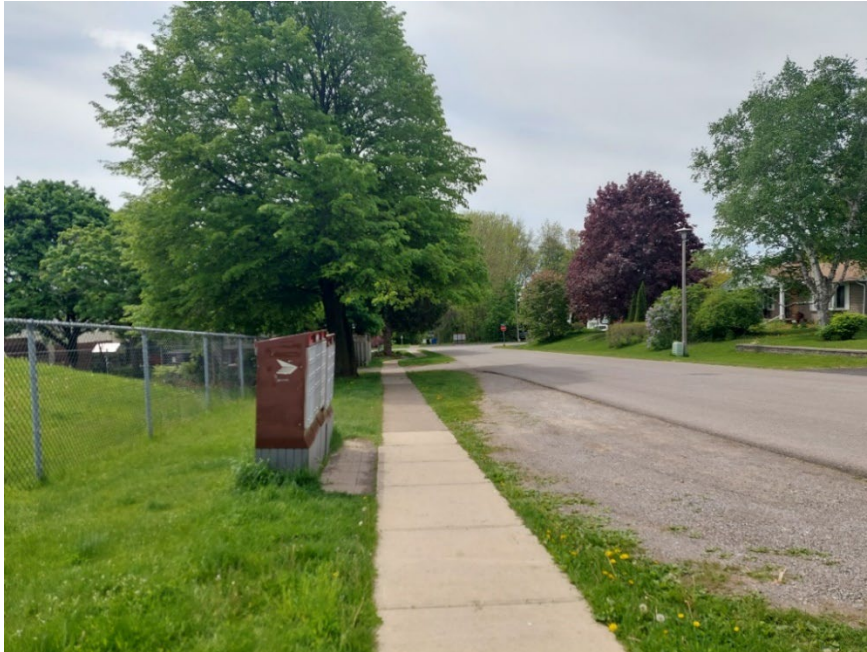
The study area includes a small portion of Shoalts Drive. Shoalts Drive is a paved undivided roadway that supports north-bound and south-bound vehicular traffic (Plate 14). There is a sidewalk on the east side of the street. The west side of the street is lined with single-family homes. The entire east side of the street is the Shoalts Drive Reservoir which has a metal fence around its entire perimeter (Plate 15).

Plate 14: Residential properties along Shoalts Drive, looking south (A.S.I., 2022).

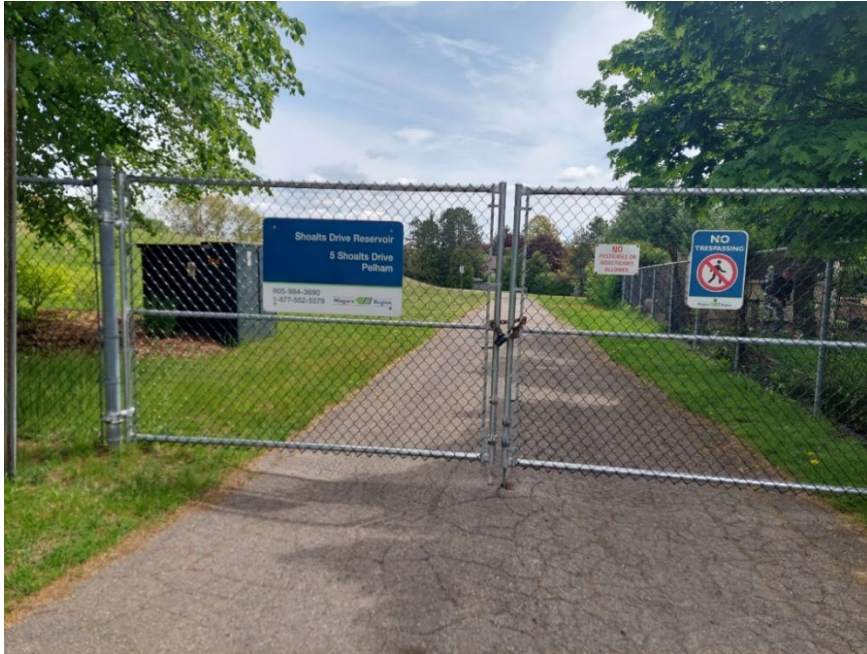
Plate 15: Entrance to Shoalts Drive Reservoir from Shoalts Drive, looking east (A.S.I., 2022).

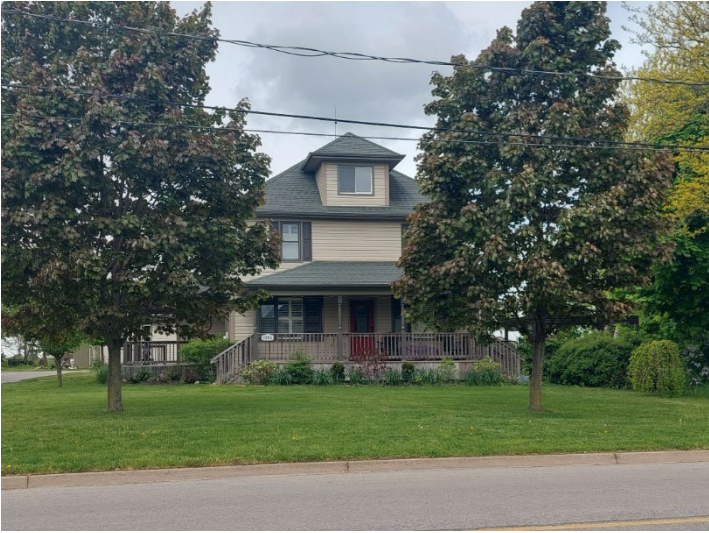
Feature I.D.	Type of Resource	Address or Location	Heritage Status and Recognition	Description of Property and Known or Potential C.H.V.I.	Photographs/ Digital Image
B.H.R. 1	Residence	1584 Lookout Street	Potential B.H.R. – Identified during field review/desktop research	<p>The property is located on the west side of Lookout Street. The two-and-a-half storey house is clad in siding and has a rectangular footprint. The house features a hipped roof and a hipped dormer along the front (east) façade. The front façade has symmetrical fenestration and a covered porch. There is a covered side entrance on the south façade. Potential heritage attributes include the two-and-a-half storey house, its height and massing, hipped roof and dormer, and covered porch.</p> <p>The 1915 topographical map (Figure 4) shows a single building in the vicinity of the extant house, with several additional buildings appearing in the 1938 topographical map (Figure 5). Based on historical mapping and the building’s vernacular architecture, the house was likely built in the early-to-mid twentieth century.</p>

<p>Plate 16: East elevation of house at 1584 Lookout Street, looking west.</p>

Indirect impacts to B.H.R. 1 and B.H.R. 2 may occur due to the location of the proposed elevated tank at the rear of the properties. This may result in **indirect adverse visual impacts** to potential heritage attributes. As such, it is recommended that a Cultural Heritage Evaluation Report be undertaken to determine if 1584 Lookout Street (B.H.R. 1) and 1574 Lookout Street (B.H.R. 2) have cultural heritage value or interest (C.H.V.I.). If either property is determined to have C.H.V.I., a Heritage Impact Assessment should be undertaken by a qualified person as early as possible during detailed design, and developed in consultation with, and submitted for review to, the Ministry and interested parties including the municipal heritage planner and/or municipal heritage committee and Indigenous Nations, as appropriate.

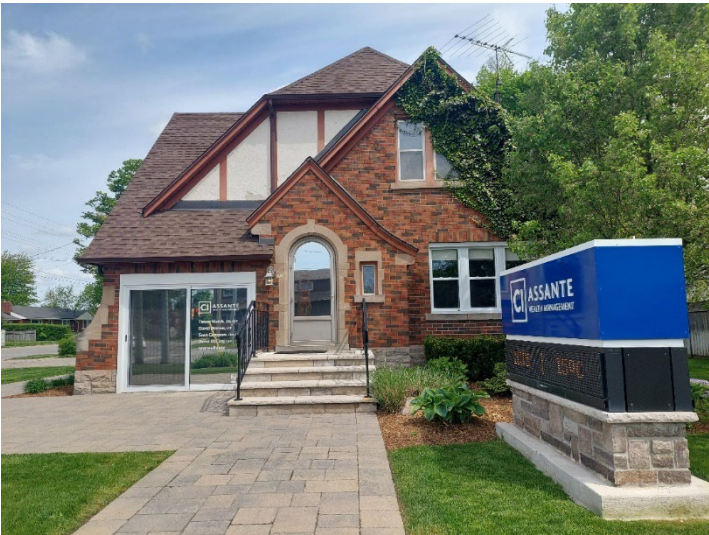
Feature I.D.	Type of Resource	Address or Location	Heritage Status and Recognition	Description of Property and Known or Potential C.H.V.I.	Photographs/ Digital Image
B.H.R. 4	Residence	77 Highway 20 West	Potential B.H.R. – Identified during field review/desktop research	<p>The property is located at the northeast corner of Highway 20 West and Haist Street. The one-and-a-half storey building is clad in red brick with stucco and half-timbering on a portion of the complex intersecting roof. The building features two front-facing gables framing the front entrance, with an arched doorway with a stone door surround. To the west of the doorway is a rectangular stained-glass window also with a stone surround. The building features casement windows with stone sills and an internal brick chimney. Potential heritage attributes include its Arts and Crafts architecture, height and massing, the complex roof, the arched front door with stone surround, and the casement windows.</p> <p>Maps dated to 1994 and earlier do not depict any buildings within the vicinity of the extant building. Based on the building’s Arts and Crafts architecture, the house was likely built in the early twentieth century.</p>

<p>Plate 19: South elevation of building at 77 Highway 20 West, facing north.</p>

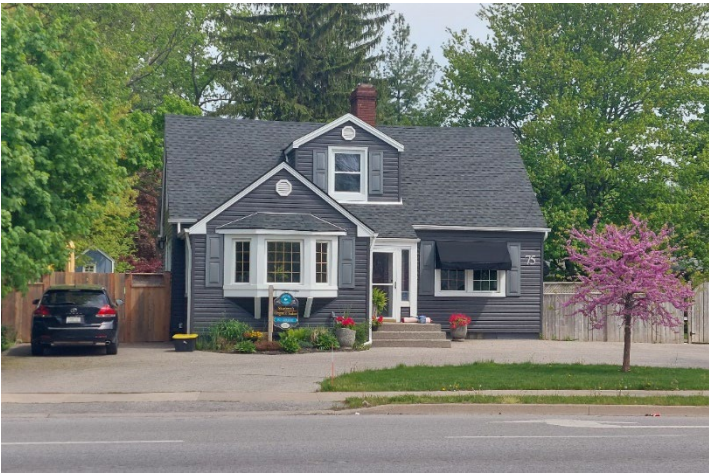
B.H.R. 5	Residence	75 Highway 20 West	Potential B.H.R. – Identified during field review/desktop research	<p>The property is located on the north side of Highway 20 West, near the intersection of Highway 20 West and Haist Street. The one-and-a-half storey building is clad in siding and features a hipped roof with a gable dormer in the centre of the front façade. The building features modern windows including a bay window. Potential heritage attributes of the building include its height and massing, internal brick chimney and the gable roof with dormer.</p> <p>Maps dating to 1994 and earlier do not depict any buildings within the vicinity of the extant building. Based on its vernacular architecture, the house was likely built in the early-to-mid twentieth century.</p>

<p>Plate 20: South elevation of building at 75 Highway 20 West, facing north.</p>

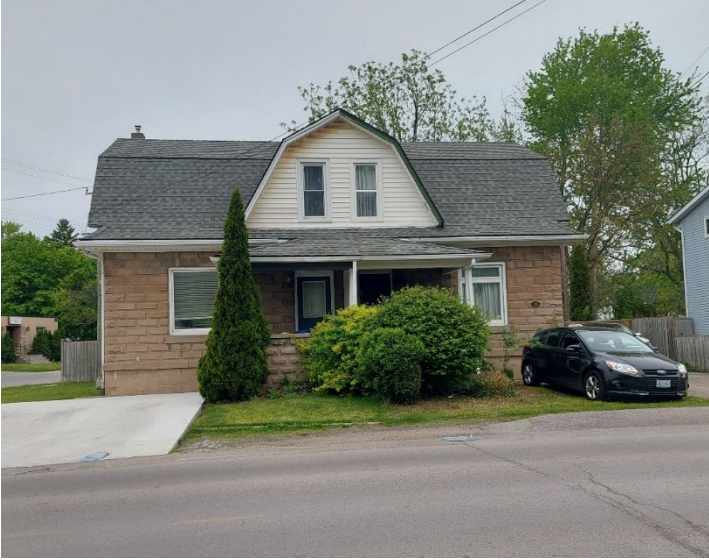
Feature I.D.	Type of Resource	Address or Location	Heritage Status and Recognition	Description of Property and Known or Potential C.H.V.I.	Photographs/ Digital Image
B.H.R. 6	Residence	109-111 Canboro Road	Potential B.H.R. – Identified during field review/desktop research	<p>The property is located at the northeast corner of the intersection of Canboro Road and Haist Street. The one-and-a-half storey house features a gambrel roof with a central gambrel dormer that is clad in siding. The house is clad in what appears to be stone. However, due to the stone’s regularity in size and lack of visible mortar, it may be a type of faux cladding. The house is evenly divided into two units with separate covered front entrances. The house features two replacement narrow, rectangular windows in the front dormer, and two replacement rectangular windows on either side of the lower front façade. The windows are encased with wood trim. Potential heritage attributes of the house include the height and massing and gambrel roof with dormer.</p> <p>The 1879 Illustrated Atlas map (Figure 3) depicts a building in the vicinity of the extant house, with more development depicted in the 1915 and 1934 topographical maps (Figure 4 and Figure 5). Based on historical mapping and the building’s vernacular architecture, the house was likely built in the late-nineteenth to early-twentieth century.</p>

<p>Plate 21: South elevation of house at 109-111 Canboro Road, facing north.</p>

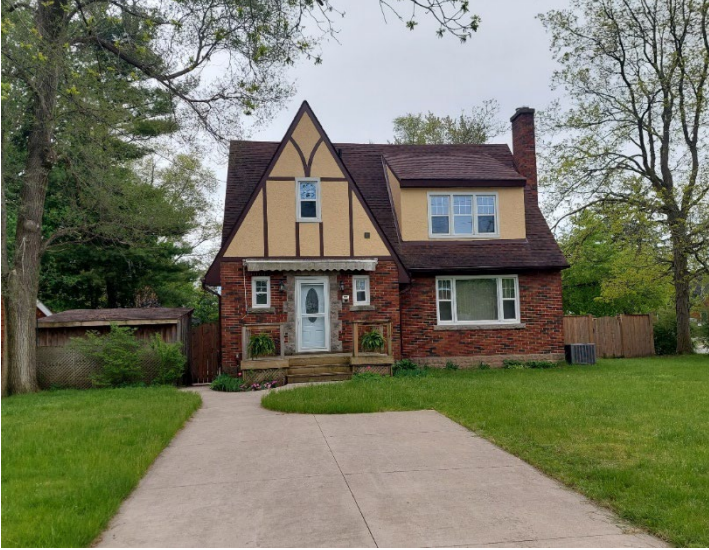
Feature I.D.	Type of Resource	Address or Location	Heritage Status and Recognition	Description of Property and Known or Potential C.H.V.I.	Photographs/ Digital Image
B.H.R. 7	Residence	108 Canboro Road	Potential B.H.R. – Identified during field review/desktop research	<p>This property is located at the southeast corner of the intersection of Canboro Road and Haist Street. The two-storey house is clad in brick on the lower level. The house features a cross-gable roof with a large front-facing gable with decorative half-timbering above the front entrance on the north facade. A rectangular dormer is also located on the north façade. The house features casement windows with stone sills and a front door has a decorative stone surround. The house features a brick external chimney on the east façade. Potential heritage attributes of the house include its height and massing, the cross-gable roof with dormer, Arts and Crafts architecture, brick chimney, casement windows and stone door surround.</p> <p>The 1879 Illustrated Atlas (Figure 3) depicts a structure in the vicinity of the extant structure, with more development depicted in the 1915 and 1934 topographical maps (Figure 4 and Figure 5). Based on historical mapping and the building’s Arts and Crafts architecture, the house was likely built in the early twentieth century.</p>

<p>Plate 22: North elevation of house at 108 Canboro Road, facing south.</p>

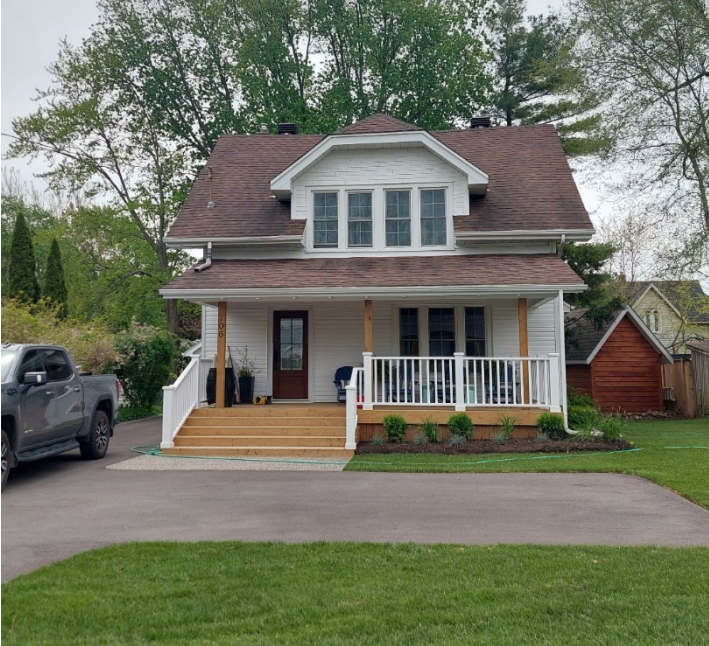
Feature I.D.	Type of Resource	Address or Location	Heritage Status and Recognition	Description of Property and Known or Potential C.H.V.I.	Photographs/ Digital Image
B.H.R. 8	Residence	106 Canboro Road	Potential B.H.R. – Identified during field review/desktop research	<p>The property is located on the south side of Canboro Road, near the intersection of Canboro Road and Haist Street. The one-and-a-half storey house is clad in siding and features a side gable roof with a central dormer on the front façade. The house features narrow, rectangular windows encased in wood and clustered in groups of three or four. The house features a covered veranda. The entrance is off-centre. Potential heritage attributes include its size and massing, side gable roof with dormer, and covered veranda.</p> <p>The 1954 aerial photograph (Figure 6) depicts a residence in the vicinity of the extant house. Based on historical mapping and the building’s vernacular architecture, the house was likely built in the early-to-mid twentieth century.</p>

<p>Plate 23: North elevation of house at 106 Canboro Road, facing south.</p>

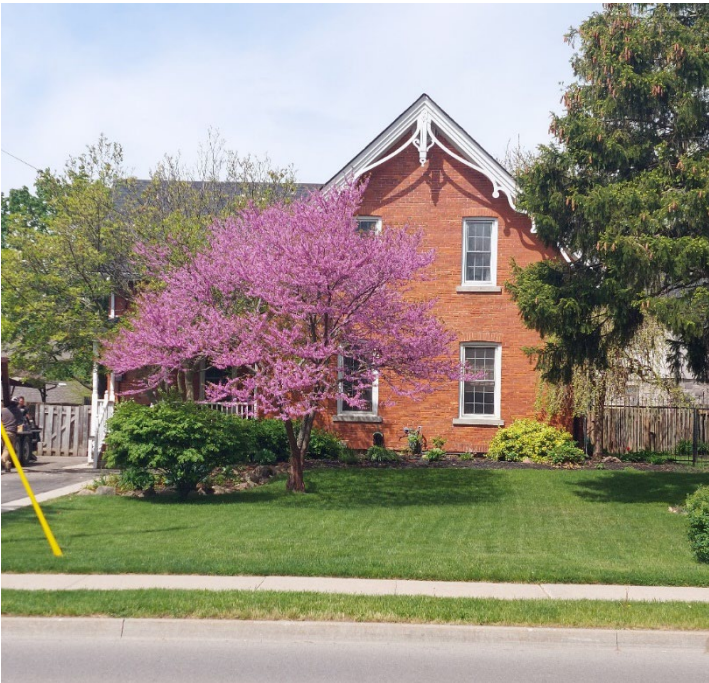
Feature I.D.	Type of Resource	Address or Location	Heritage Status and Recognition	Description of Property and Known or Potential C.H.V.I.	Photographs/ Digital Image
B.H.R. 9	Residence	1374 Haist Street	Known B.H.R.- Listed on Municipal Heritage Register	<p>The property is located on the west side of Haist Street, just south of Canboro Road. The known heritage attributes include a two-storey residence that was constructed in 1870 by Christian Haist (Town of Pelham, n.d.-b). The house is an example of vernacular Gothic Revival farmhouse architecture. The house is clad in red brick and features a cross-gabled roof and an off-centre enclosed, raised porch with turned spindle porch columns. The windows feature flat, rectangular openings that are accentuated with flat brick arches and plain stone lug sills. There is ornate bargeboard along the gable on the front of the house.</p> <p>The 1879 Historical Atlas (Figure 3) depicts the property with an orchard directly to the south of it.</p>

<p>Plate 24: East elevation of house at 1374 Haist Street, facing west.</p>

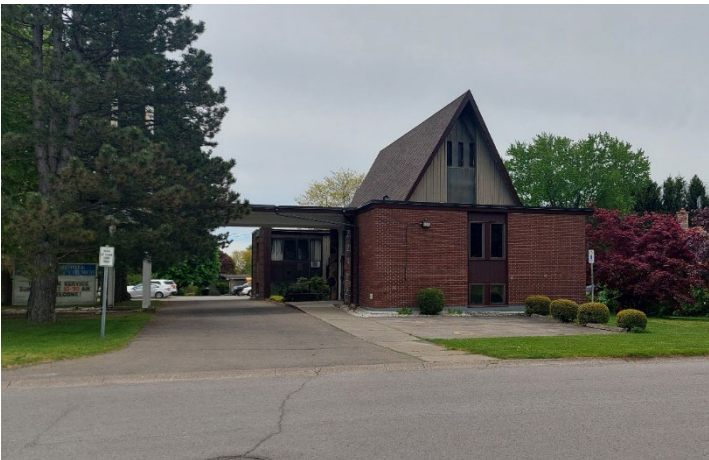
Feature I.D.	Type of Resource	Address or Location	Heritage Status and Recognition	Description of Property and Known or Potential C.H.V.I.	Photographs/ Digital Image
B.H.R. 10	Church	1344 Haist Street	Potential B.H.R. - Listed in the Ontario Heritage Trust (O.H.T) Places of Worship Inventory	Kirk-on-the-Hill Presbyterian Church on Haist Street is included on the Ontario Heritage Trust’s Places of Worship Inventory. The church was built in 1963. Potential heritage attributes of the church include its irregular, asymmetrical massing, Modernist architecture, and brick veneer. The 1973 topographic map (Figure 7) depicts the church.

<p data-bbox="2147 923 2837 1010">Plate 25: Northeast elevation of church at 1344 Haist Street, facing southwest.</p>
B.H.R. 11	Residence	1200 Haist Street	Potential B.H.R. – Identified during field review/desktop research	<p data-bbox="1013 1064 2125 1366">The property is located at the southwest corner of the intersection of Haist Street and Pancake Lane. The one-and-a-half storey house is clad in wood siding. The house features a gable roof and narrow, rectangular windows. The front entrance of the house is on the north façade. A two-storey addition appears to have been added to the west end of the house. Potential heritage attributes of the house include its height and massing and gable roof.</p> <p data-bbox="1013 1407 2104 1574">The 1915 topographical map (Figure 4) depicts a structure in the vicinity of the extant house. Based on historical mapping and the vernacular architecture of the house, it was likely built in the late-nineteenth or early-twentieth century.</p>

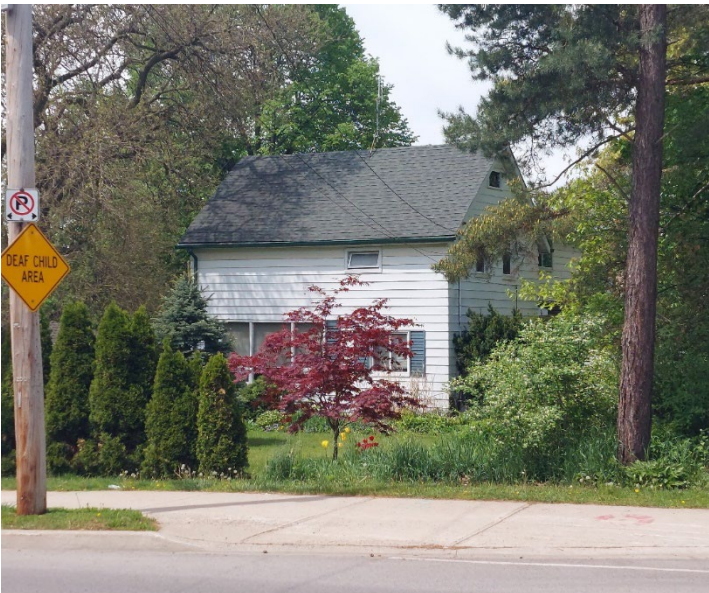
<p data-bbox="2147 1645 2837 1731">Plate 26: Northeast elevation of house at 1200 Haist Street, facing southwest.</p>

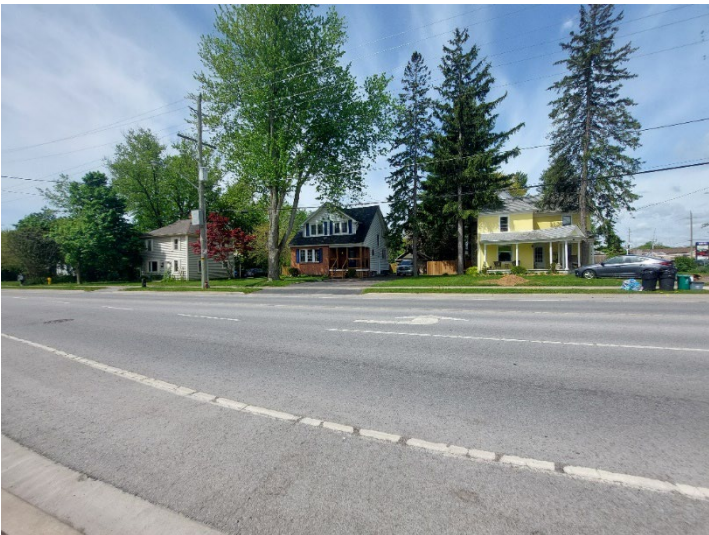
Feature I.D.	Type of Resource	Address or Location	Heritage Status and Recognition	Description of Property and Known or Potential C.H.V.I.	Photographs/ Digital Image
C.H.L. 1	Residential Streetscape	Haist Street between Highway 20 West and Canboro Road	Potential C.H.L. – Identified during field review/desktop research	<p>The streetscape is located along Haist Street between Highway 20 West and Canboro Road. The streetscape includes a collection of buildings that range in architectural styles and is representative of historical residential settlement patterns. A masonic temple built in the mid-twentieth century is the only non-residential building included in the streetscape. Historical mapping indicates that settlement along this portion of Haist Street began in the late nineteenth century, with the rest of the residential street filling in during the 1930s and 1940s. The streetscape features mature trees that line the street and fairly uniform setbacks of the houses. Potential heritage attributes of the streetscape include a variety of architectural styles, mature trees, and historical residential development patterns. The 1938 topographical map (Figure 5) depicts several buildings in the extant streetscape.</p>

<p>Plate 27: East elevation of Haist Streetscape, facing southwest.</p>
