APPENDIX B - BRIDGE INSPECTION REPORTS

Structure Name ID Number	St. Paul West CNR Bridge 081215		
Classification	✓ Bridge Culvert	Structure Municipal	
Location	081 St. Paul Street West, 0.50 km E of	072 Louth Street	
Load Posting	15, 30, 40	Span Lengths	16.8 m
		Board Order / Agreement	\checkmark
Structure Type	SOSG		
Yr Constructed	1910		
Yr Rehabilitated	N/A		
Inspection Date	10-Nov-17	Current AADT	7950
Previous Inpsection	21-Aug-15	Date AADT	1992
Next Inspection:	2019	Previous ID Number

LOAD CAPACITY EVALUATION OF ST. PAUL STREET WEST CNR BRIDGE (STRUCTURE NO. 081215) IN THE CITY OF ST. CATHARINES MILE 11.68 GRIMSBY SUBDIVISION

Reference: Load Capacity Evaluation (LCE) for the St. Paul Street West CNR Bridge, Region Structure No. 081215, Mile 11.68 Grimsby Subdivision. Our File No.: 848.

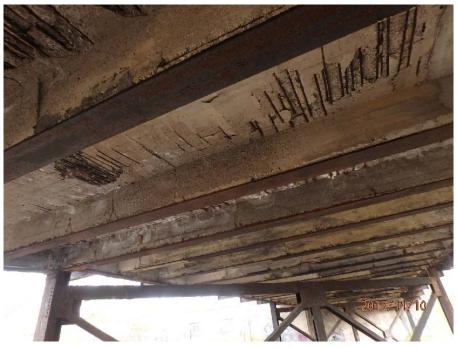
Photograph No. 2: 0465: Very severe concrete spalling on bridge deck soffit.

The bridge deck soffit is in very poor condition with extensive areas of severe spalling with exposed corroding reinforcing steel, delaminations, and leakage. There is severe leakage through the bridge deck as evident on the abutment walls.

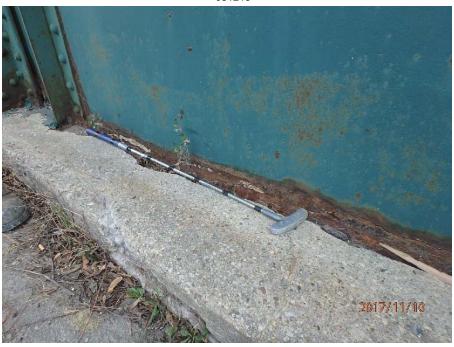
Photograph No. 3: 0430: Perforation in the through-plate girder web

The main steel through-plate girders above the bridge deck are in poor condition. There is severe corrosion and section loss of the webs along the sidewalks and curbs. There is an area of severe corrosion and web perforation (approximately 600mm long and up to 25mm wide) at the curb line of the south girder of the west span near the west column. Several of the stiffeners are perforated at the sidewalk level. There is severe crevice corrosion between the built-up flange plates that has warped the plates and caused several rivets to fail. The east end of the south through-plate girder has rotated to the west.

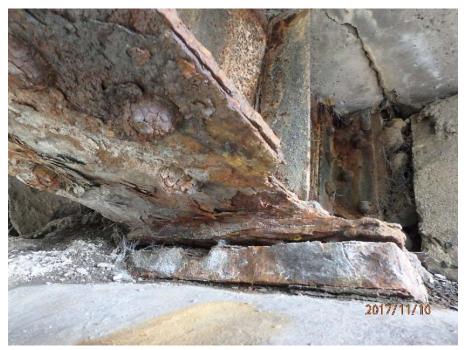
Photograph No. 4: 0541: Section loss of the bottom flange of the through plate girder at the south east bearing

The longitudinal through-plate girders below the bridge deck are in poor condition with areas of severe corrosion and significant loss of cross-sectional area and loss of rivet heads at the abutments. There is severe section loss and perforations through the bottom flange next to all the bearings.

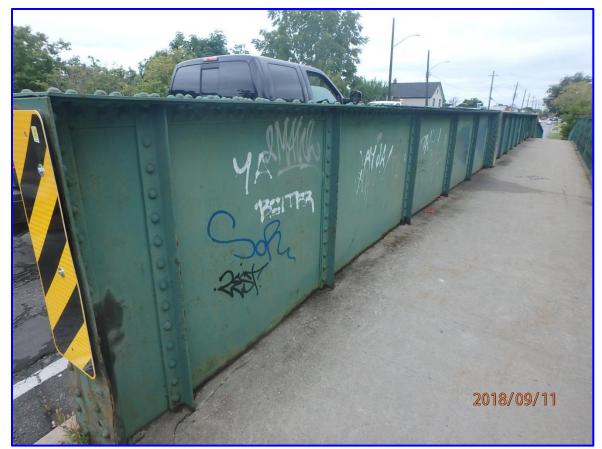
Photograph 1 – East end of the north through-plate girder

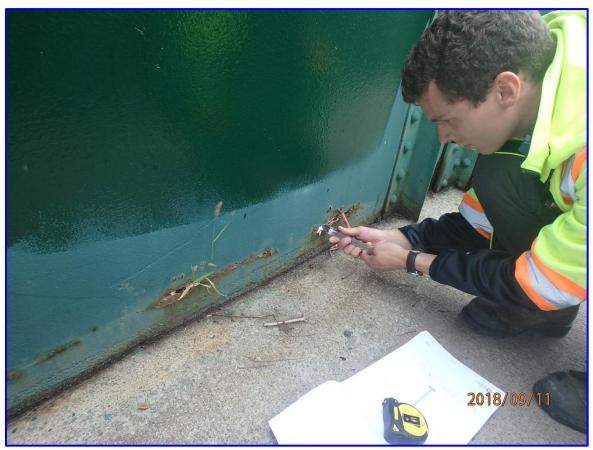
Photograph 2 – *Perforations through the web of the south through-plate girder*

The finite element mesh model confirmed the results of the finite element beam model. By modelling and analyzing the web perforations in the finite element mesh model, it was determined that there is no significant reduction in the structural capacity of the girders at the locations of the web perforations. However, any significant increase in the size or number of perforations may require re-analysis of the girders.

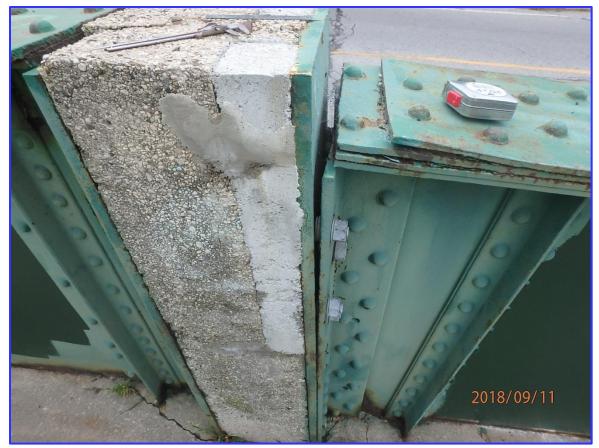
The connection between the top of the northwest pier column and the west span north throughplate girder is beginning to separate (25mm) and has caused several rivets to fail. These rivets have been replaced with bolts.

Photograph 3 – Failed rivets and separation of girder at northwest pier column

The riveted connections of the girders to the pier columns were analyzed for live load capacity. It was determined that the rivets at the top of the connection do not have sufficient structural capacity to carry live loads. This confirms the observations from the site inspection, where the top rivets of the northwest column have failed and the west span north through-plate girder is beginning to separate (Appendix 'A', Photograph 3). The failed rivets at this location have been replaced with bolts.

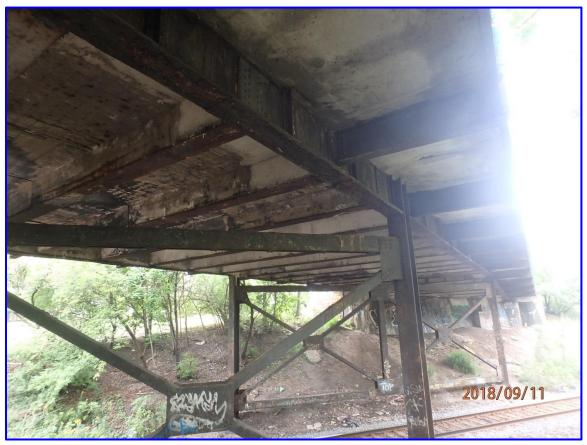
Photograph 4 – Underside of structure looking southwest

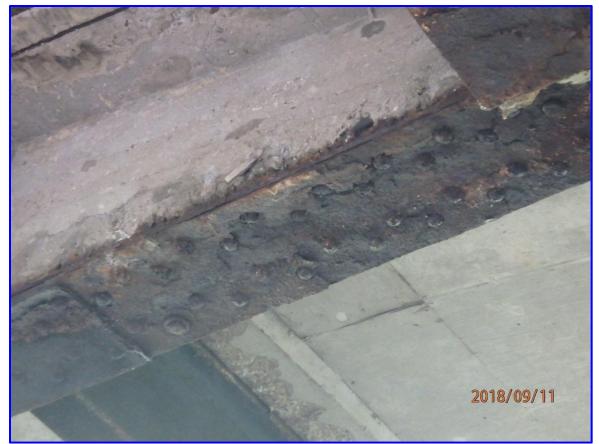
Photograph 5 – Severe corrosion on underside of main girder bottom flanges

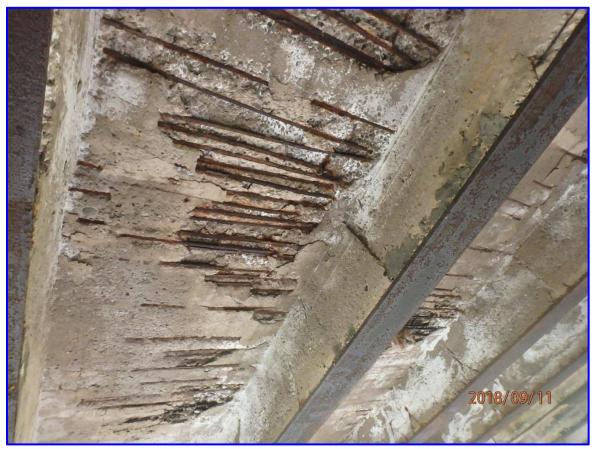
Photograph 6 – *Deterioration in concrete bridge deck soffit (typical)*

The concrete deck was analyzed for punching shear in accordance with the bridge code. No immediate concerns were found for live load punching through the deck. However, with the severe spalling of the underside of the concrete deck, continued deterioration may result in small holes developing in the deck.

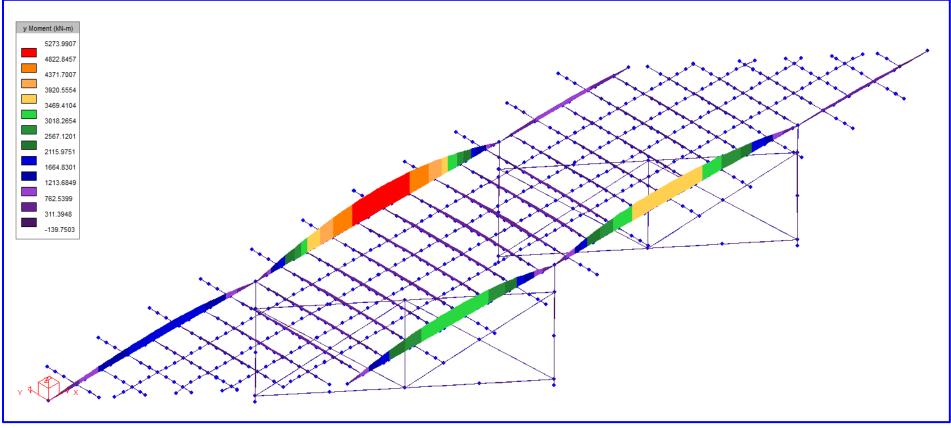
Screenshot 1 – ULS Total Bending Moments on Finite Element Beam Model
